Manhole Inspection Summary

Manhole # S07KK1006MH

Insp Date: **5/18/07 1:48 PM**

Location Address: **5001 REISTERSTOWN RD**

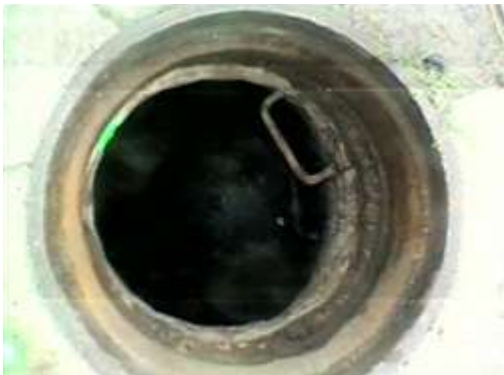
Top View

NOTE DEBRIS ON BENCH AND IN CHANNEL

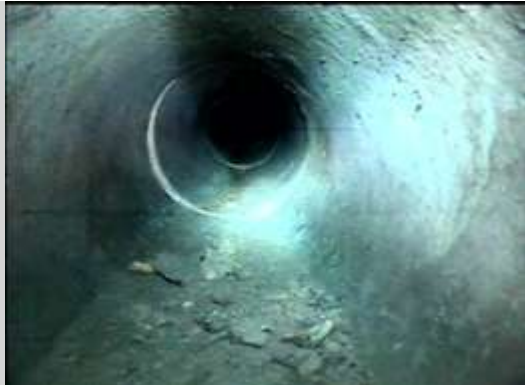
12 O'Clock Outflow

NOTE DEBRIS IN CHANNEL

Deposits: ☐ None ☐ Mud ☐ Sludge ☒ **Debris** ☐ Grease

Silt Depth: **0.25** (in.) Deposits Extent: **Light**

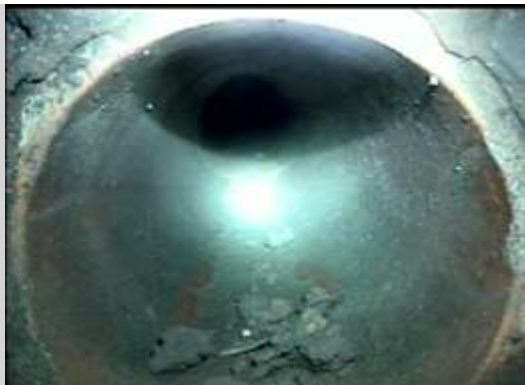
6 O'Clock Inflow

NOTE DEBRIS IN CHANNEL
